Journal of Management & Social Science

[Socio-Economic and Environmental Impacts of Flood 2010 in Lower Dir District and Mitigation Measures]

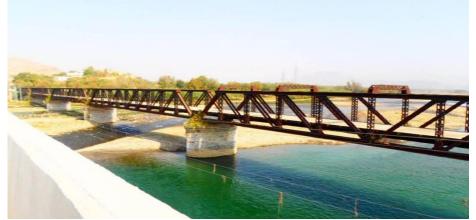
Figure 1 British - Era Bridge of Chakdara, Built in 1902 used for Light Traffic After Flood. Source Flickr

The destroyed bridges included Chakdara, Balambat, Japani pull, Sherpalam, Khall, Ashari Gat, Khazana Bypass, Khadegzai and Zolam. Locals were using old routes to continue their daily lives and businesses due to road closures. (BBC, 2010). The floods had severely impacted the districts of Lower Dir. The crucial bridges connecting Chitral, Swat, as well as the tribal area of Bajaur Agency through Lower Dir partially collapsed, disrupting traffic and communication in these areas. The Pakistan Army had temporarily restored traffic flow by repairing a nearby British - era bridge, built in 1902. However, only light vehicles were allowed to cross, and heavy traffic, including cargo trucks, was prohibited due to safety concerns.

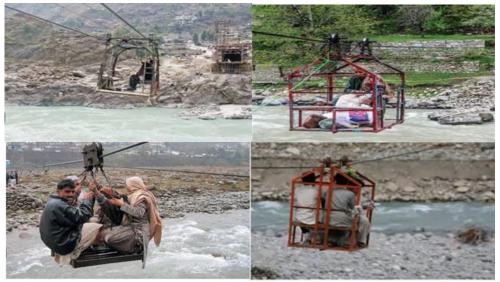
To cross the river, especially in areas where bridges have been destroyed. Locals were also using makeshift Chairlifts, Known as "Zango". While these chairlifts were not safe, they were the only means of crossing the river for many residents. The floods have caused widespread destruction, including:

Figure 2 Locals were using Makeshift Chairlifts, Known as "Zango". Source Flickr Immediate Recovery Efforts

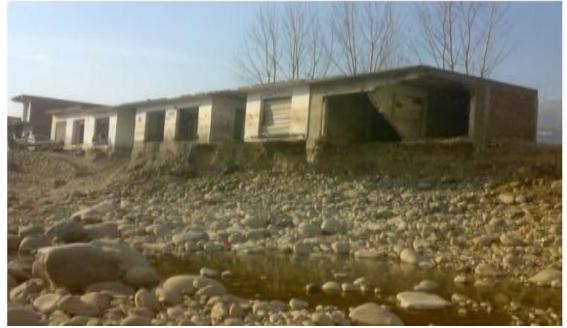
four markets were entirely washed away by the floods, while several others sustained partial damage. In total, 287 shops within these six union councils were damaged, 223 were totally smashed, and resulting in an appraised value of Rs. 226.5 million (refer to Table No.6). The Union Council (UC) Khall experienced the most severe market devastation, where 221 shops were either damaged or destroyed, incurring losses amounting to Rs. 166.3 million. Notably, the primary market in UC Khall, which span over both sides of the river, was heavily impacted. The market towards the main town of Khall was fully erased, whereas the market on the left-side suffered approximately 62% structural damage (Figure 3). Additionally, the floods led to the destruction of 26 kanals of commercial land, contributing to an estimated loss of Rs. 36 million.

Figure 3: Shops Destroyed Be The Recent Flood Photograph Taken In December, 2010
